HARFORD COUNTY DPW

UPPER FARNANDIS SMALL WATERSHED ASSESSMENT REPORT

APRIL 02, 2018

HARFORD COUNTY DEPARTMENT OF
PUBLIC WORKS

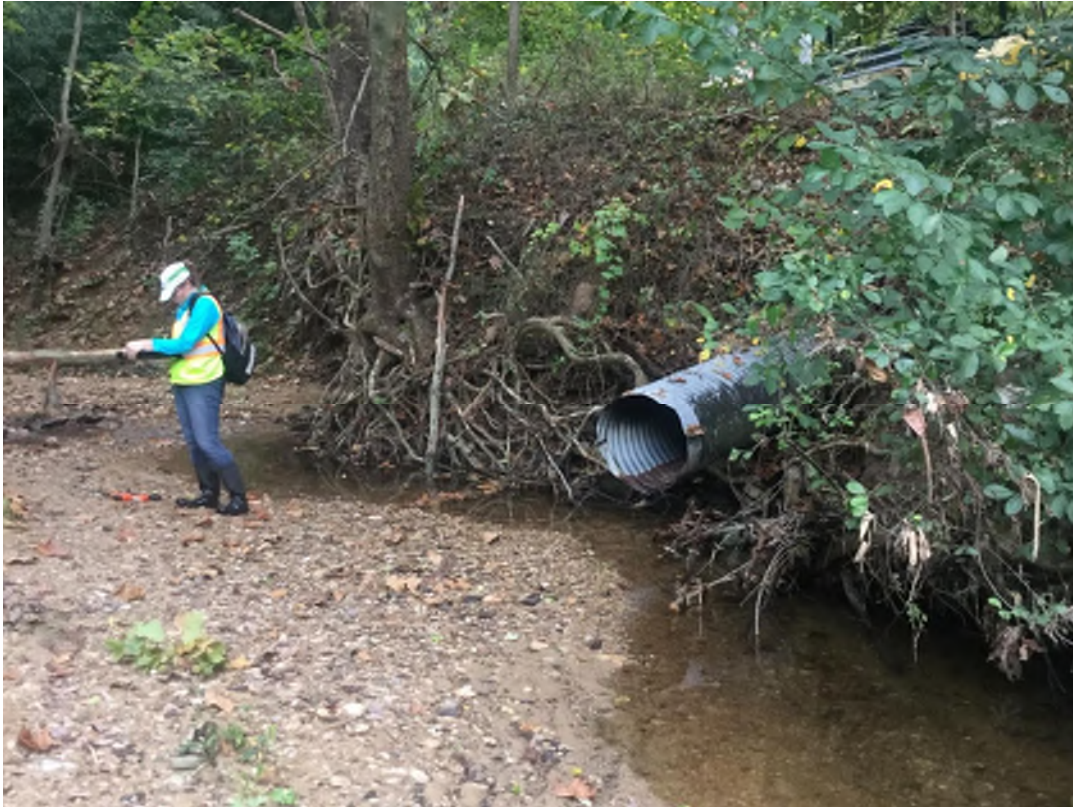
Figure 9: Outfall 8 is a 24-inch metal pipe conveying flow to the left bank of the mainstem. Invert of outfall is one foot above water surface.

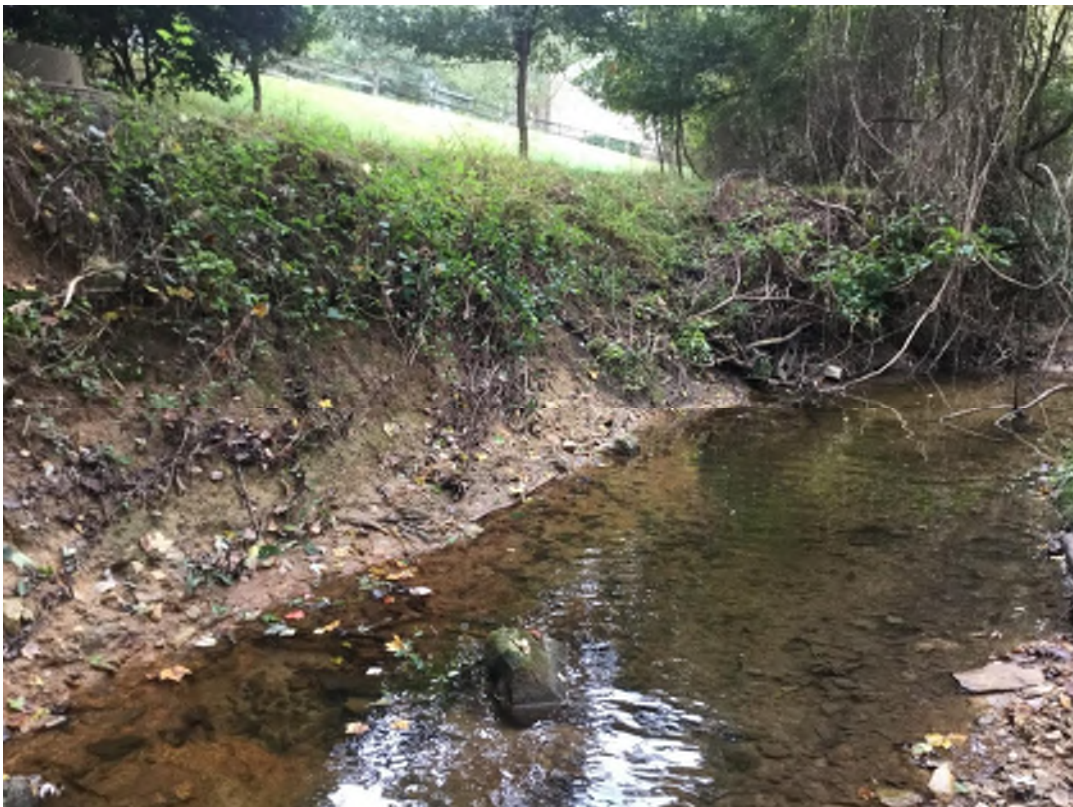
Figure 10: Bank erosion in mainstem downstream of outfall 8.

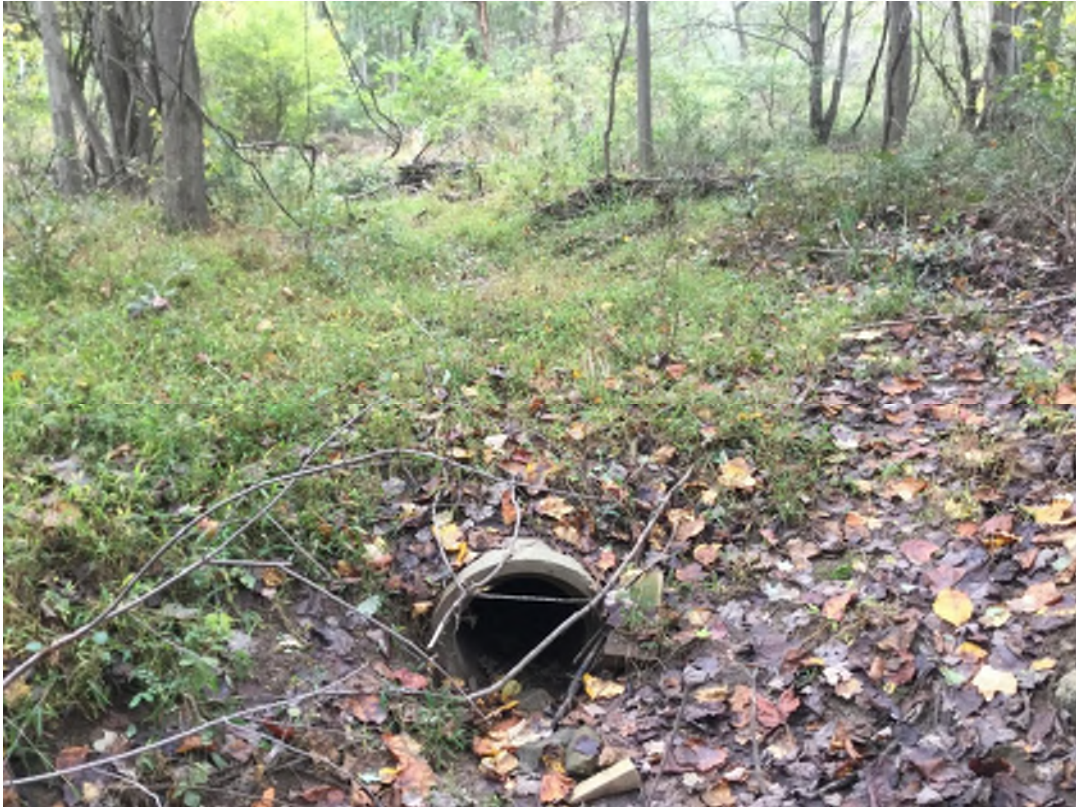
Figure 11: 12-inch reinforced concrete drainage ditch culvert that parallels mainstem.

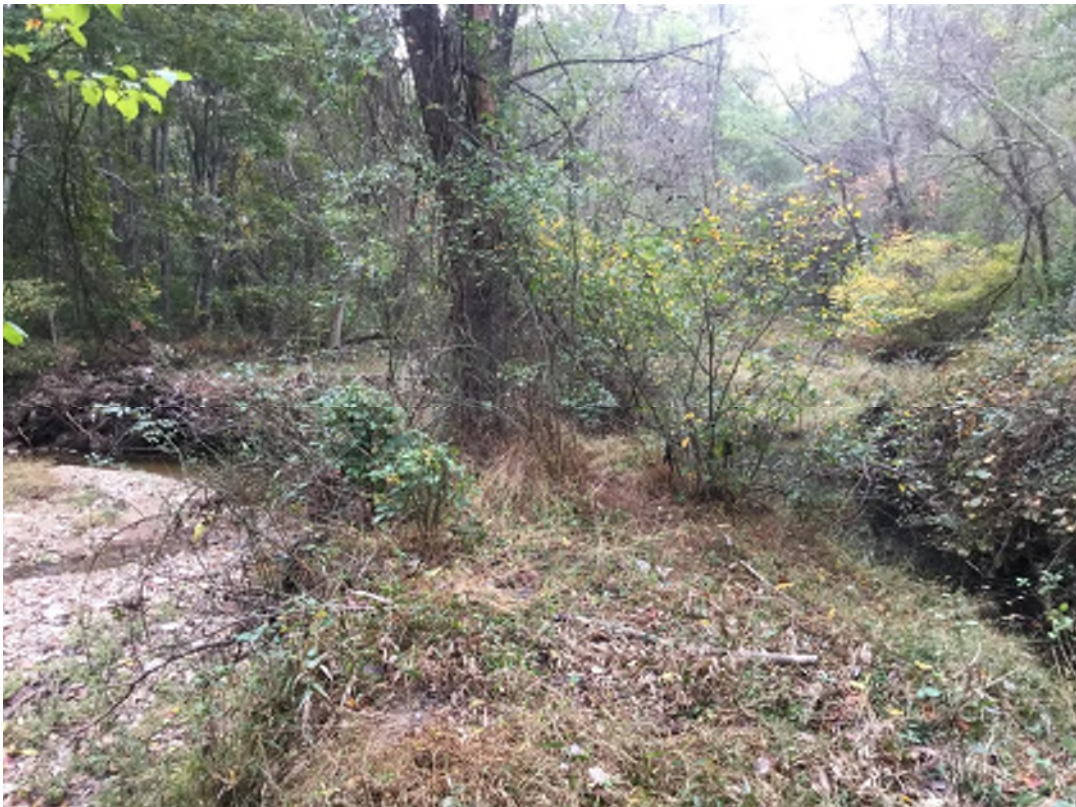
Figure 12: Beginning of abandoned channel in mainstem. Stream has shifted.

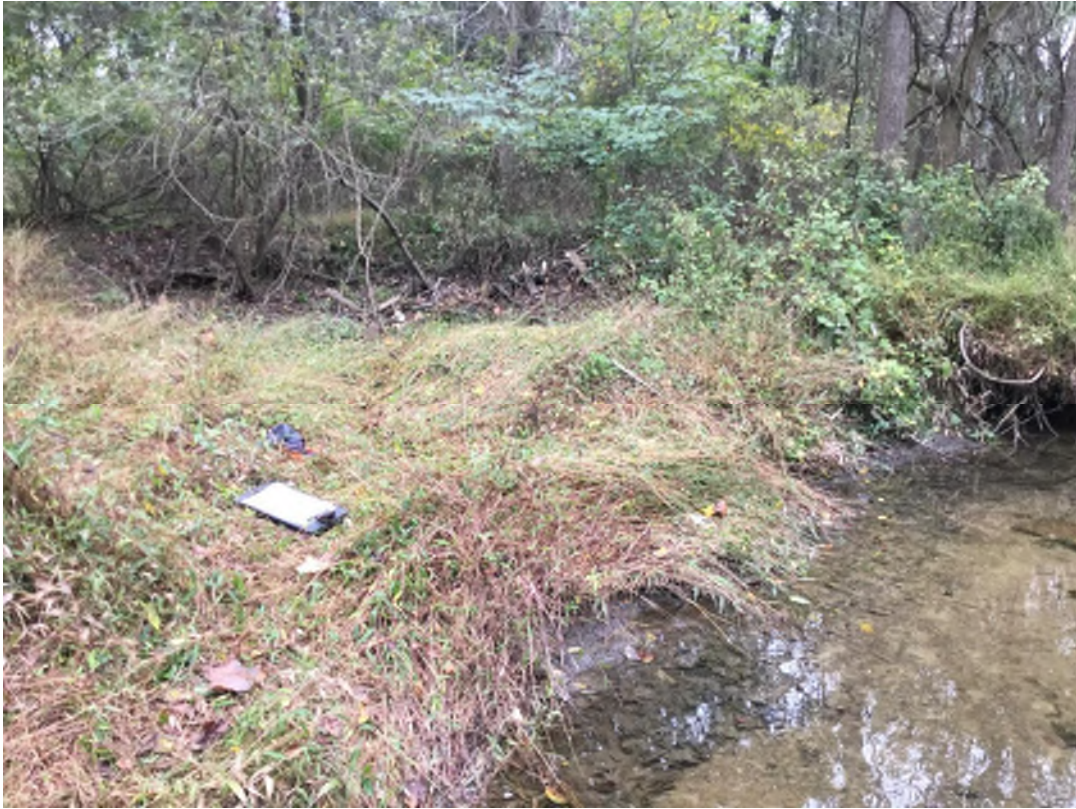
Figure 13: Abandoned channel in mainstem.

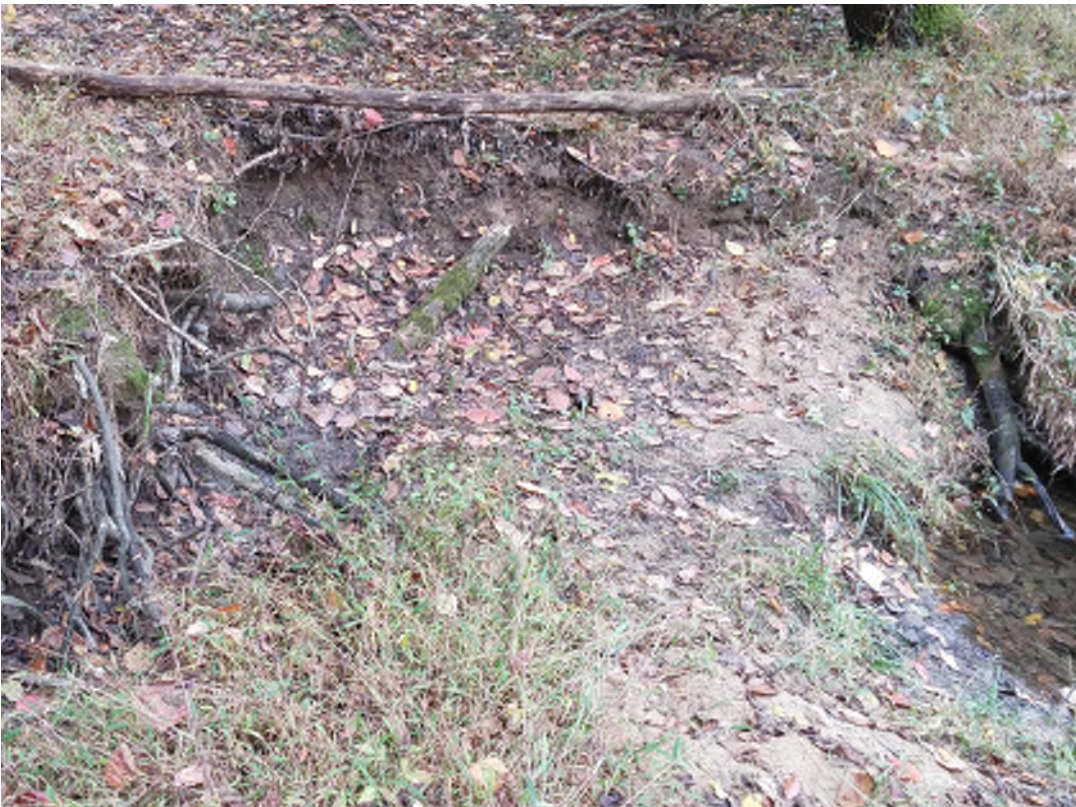
Figure 14: Abandoned channel meets existing channel in mainstem.

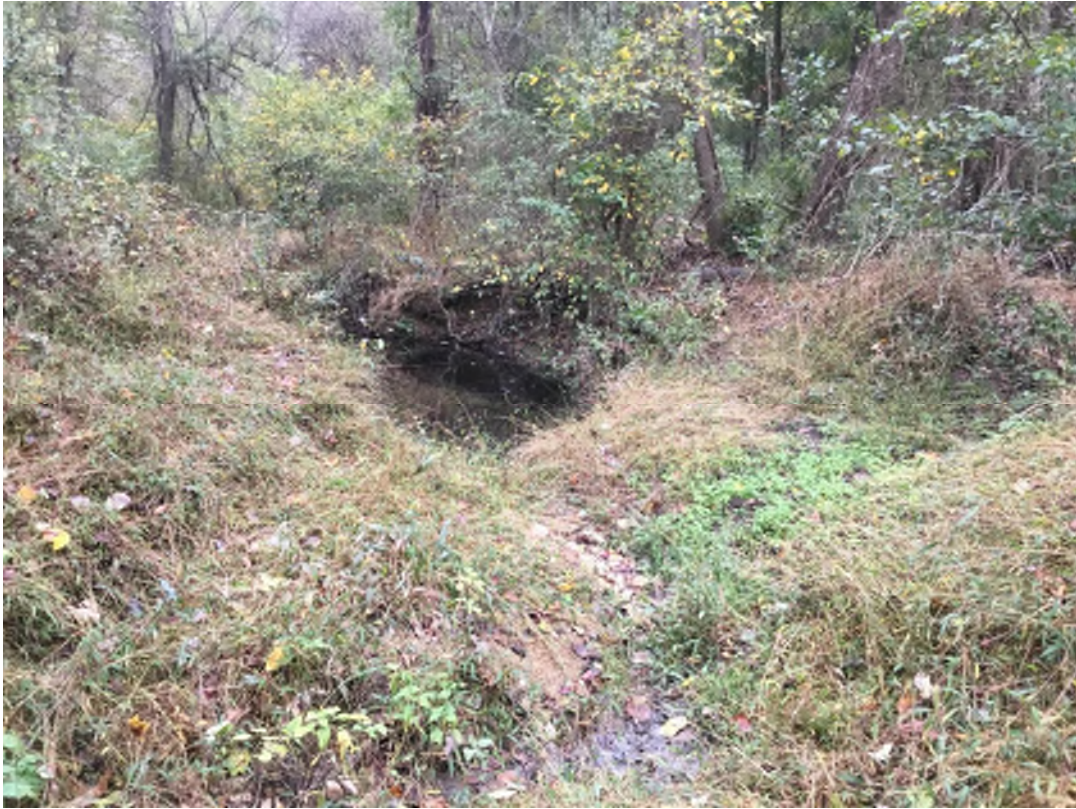
Figure 15: End of abandoned channel in mainstem.

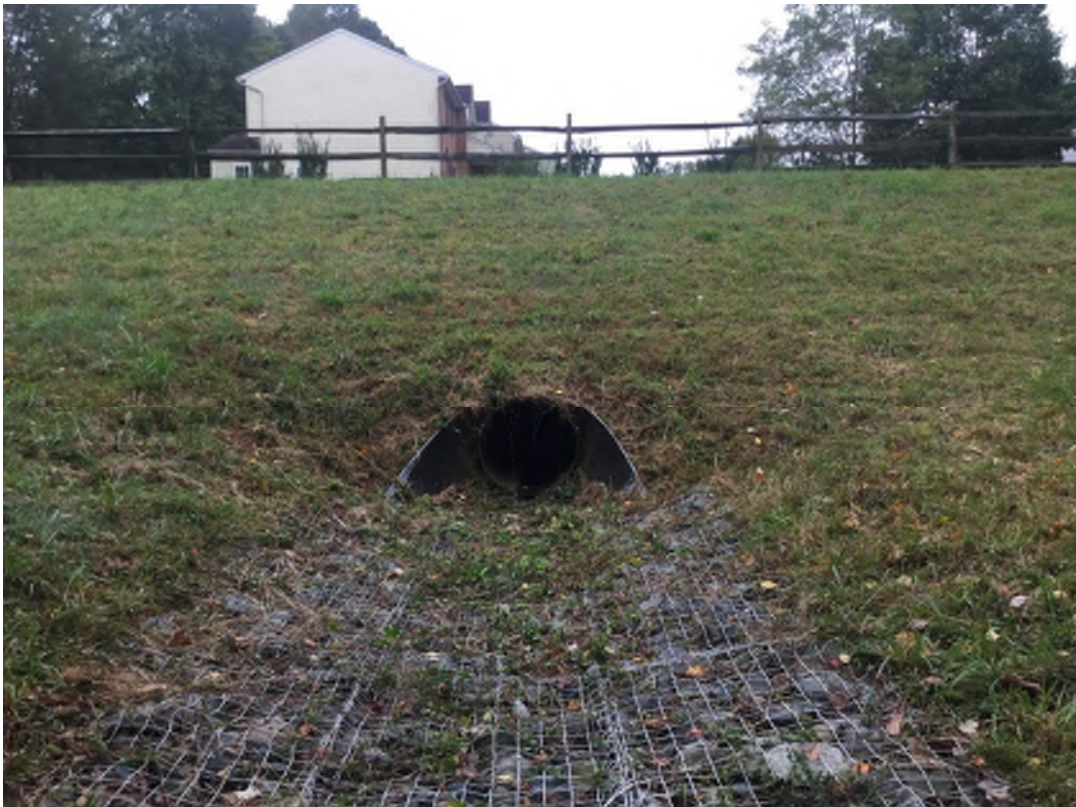
Figure 16: Outfall 10 is a 24-inch metal pipe conveying flow to the right bank of the mainstem. Outfall is in tributary 2 and is 50 feet to the stream.

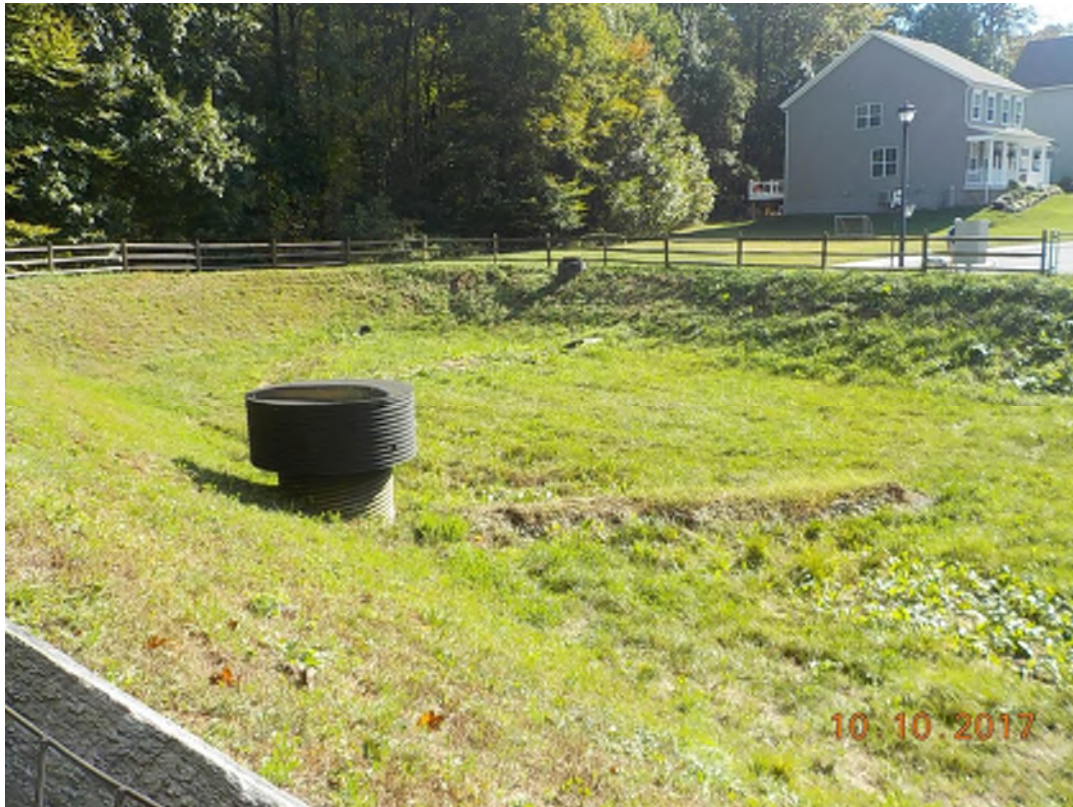
Figure 19: Existing BMP 4 is an extended detention basin at the Northern end of Raspberry Hill Court. Inflow from the surrounding neighborhood via three pipes. Outfall via metal riser to gabion outfall protection. Proposed wet pond retrofit.
